Road Damage Classification using Back Propagation Algorithm

Abstract : Industrial development in Indonesia impact to the road damage at several districts. Because the industrial transport which owned by some industry to distribute the product were heavy transport, so the road damage could not be avoided. So that, the government was expected to be able to detect the road damage earlier before many traffic accident in various districts happened. To support the government performance handling the road damage, the government has to be able to have classifications the road damage so the government does not wrong in handle the damage. As the technology development, the government could apply information technology to have the road damage classifications using computer. Backpropagation method was one of the neural networks method that able to do road damage classifications. With the digital image processing support, system would have good accuracy. Some of digital image processing method used for cropping, edge detection, and thresholding. The data used in this research was a photograph from the highway, where the data consisting of road damage image and a photograph of the road that the

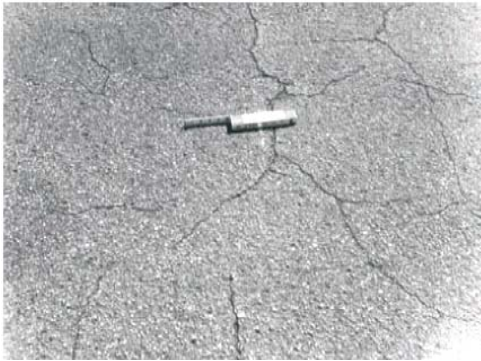
Cracked block was a crack that form a series of checkered shaped quadrangle and interconnected. Extensive cracks block about 200mm until 3000mm. The hexagonal form occurred as a result of damage from pavement concrete connection asphalt layer. This was caused by shrinkage on the cement material. As for the image of a cracked block damage could be seen from figure 1.

Figure 1. Block Crack

In figure 1 had shown form of block crack. Besides block crack, an other kind of a rift were alligator crack. Where a rift shaped in a small polygon connection and integrated similar like alligator skin, generally, rift size ranged from 150mm until 300mm. This was cause by less thick pavement, the form of a alligator rift could be seen in figure 2.

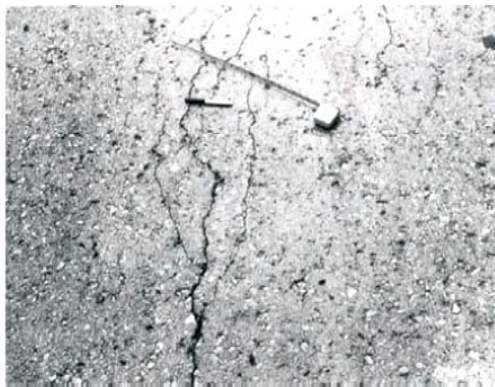
Figure 2. Alligator Crack

According to figure 2, a kind of a rift shaped into a small connected polygon called with alligator crack. The road damage not only alligator crack, but also there was a types of a rift in being irregular crack. Irregular crack due to the weak bond between the top surface layer with the lower layer. As it would cause the land slide, the cause of another irregular crack were low basic land modulus and thin surface coating. An irregular rift not only happened from the result asphalt or land conditions, but also from the vehicles passing, some of them because the asphalt dragged down by a vehicle. A kind of an irregular rift was presented in figure 3.

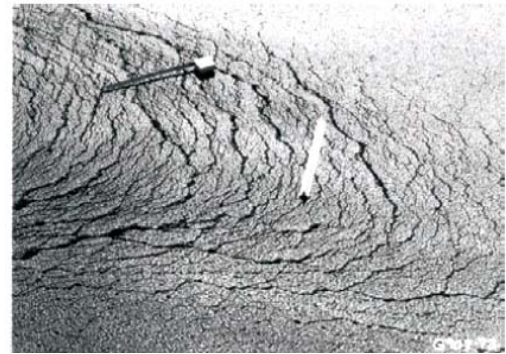
Figure 3. Irregular Crack

Irregular crack has been served in figure 3, where the road was shifted. Because Of this shifted, cause the road damage. Besides block crack, alligator crack, and irregular crack there were also types of transvere rift. Transverse crack happened as a result of shrinkage connection to the concrete or cement layers. As for the picture of transverse crack transverse presented at figure 4.

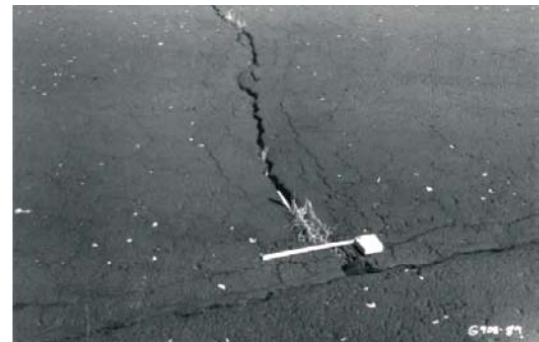
Figure 4. Transverse Crack

In figure 4 has been shown a picture of transverse crack, where the rift looked perpendicular to the axis the road. Based on the rift types on the road we would like to built a system that have knowledge to do damage classifications on the highway, especially rift way. Some associated research that has been done was by Cahyono [4]. On that research has been made a system to detect road surface damage using template matching methods. The system was made to detect the road damage. The data used in the research using picture of the normal and broken highway. Before the pattern recognition of damaged and normal roads, would do the digital image processing and extraction first. System would using 10 template and 20 template, where the system accuracy for 10 template was 60 % and 75 % for 20 template. There was also research on evaluation on the damage level by suswandi et al in 2008 using the pavement condition index (pci) to supporting the decision-making. Pci could help in choosing or prioritise which road that need to handle first. Where the road with the smallest value need to handle quickly. Besides research about road damage, in the transportation field there were also research on detection and vehicle clasification done by adistyia, and muslim [7]. In detecting and classifying, researchers used backpropagation neural network method, and using a method of digital image processing in doing the edge detection using sobel. Where the system could detect the form of car with highest accuracy about 94 %. But on that research, the system has not been able to recognize the type of vehicle more specific.

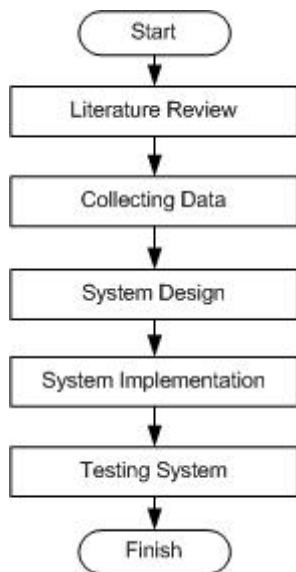
Figure 5. Research Phase

In figure 5 has been shown every stage which will done in this research. The first phase was doing the literature study on the types of the damage and the methods used in this research. After literature study phase continued with

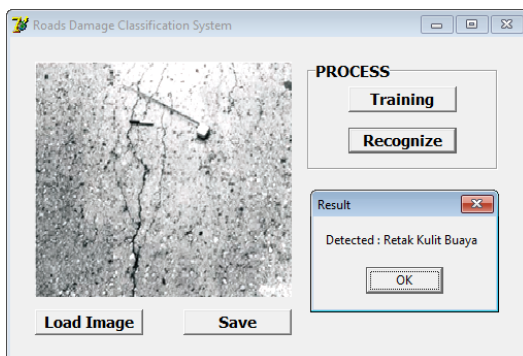
Figure 7. Implementation of Road Damage Classification System

In figure 7 shown the recognition process, and from the recognition process have results of the classifications. But before doing the recognition process like explanation before, it must completed training data first. The training data was undertaken from the data that have been stored in the database. For the data used in the training process was 200 data image. From the total of 200 image data that consist of 50 block crack image, 50 alligator crack image, 50 irregular crack image, and 50 transverse crack image. While for the number of image used for the recognition process was 100 image, consisting of 25 crack block image, 25 alligator crack image, 25 irregular crack image, and 25 transverse crack image. The training process done with backpropagation algorithm with 1000 iteration. While for learning rate used were 0.05, 0.005, and 0.0005. The number
